CORRYONG GRANDSTAND

Corryong Recreation Reserve, Strzelecki Way, Corryong 3707

Heritage Place Citations

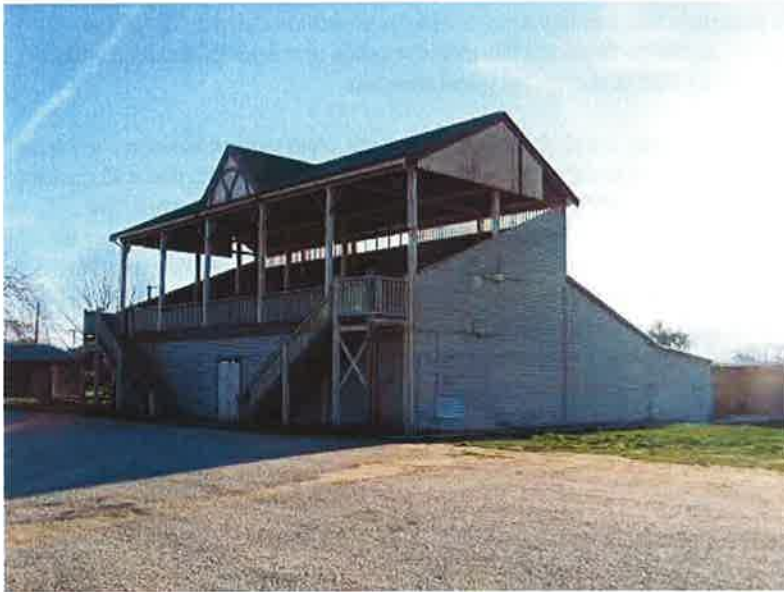
The grandstand is a substantial two-storey timber-framed building set back from an oval with a gravelled roadway in between. The grandstand is comprised of a raised seated area with an understorey which extends to a single-storey section at the rear.

The two-storey front section has a gable roof with an additional, smaller gable to the façade. The gable ends are clad in vertical timber boards, the larger with scalloped edging (some boards are missing); the smaller also with a timber interlocking circle pattern. The king truss roof framing is exposed with unpainted timbers. The single sections to the rear have skillion roofs with skylights. There is a flat-roofed veranda to the south elevation with metal posts and concrete paving. The roofs are clad in corrugated metal sheeting.

The detailing of the upper storey is restrained – there are chamfered timber posts, plain vertical balusters (some are missing and other sections replaced with corrugated metal sheeting), and vertical fretwork to the rear wall (missing in the middle). The most elaborate element is the brackets to the posts across the front of the structure. The seating likewise is simply detailed with only a post and rail system to define the backrests. The upper storey is accessed by a flight of stairs at either end, which extend across the façade. A series of *ad hoc* repair works have been undertaken, for instance an additional rail has been added over existing and deteriorated balusters have been replaced with different elements. The side, angled walls at the first floor level, are clad in corrugated metal sheeting, horizontally orientated and unlined. The latter extends over the other enclosed sections of the building.

Reinstate missing timber elements including: vertical timber boards with scalloped edging to the gable ends, vertical fretwork to the upper rear wall, original railings, balusters which have been replaced with different elements.

Repaint, preferably undertaking paint scrape analysis to determine original colour scheme.
